CLARK FORK RIVER IRRIGATION DIVERSIONS PROJECT FINAL REPORT

Missoula County Conservation District

**December 1995
P11372.00**

**Prepared by
Acres International Limited
Suite 500, 10201 Southport Road S.W.
Calgary, Alberta
T2W 4X9**

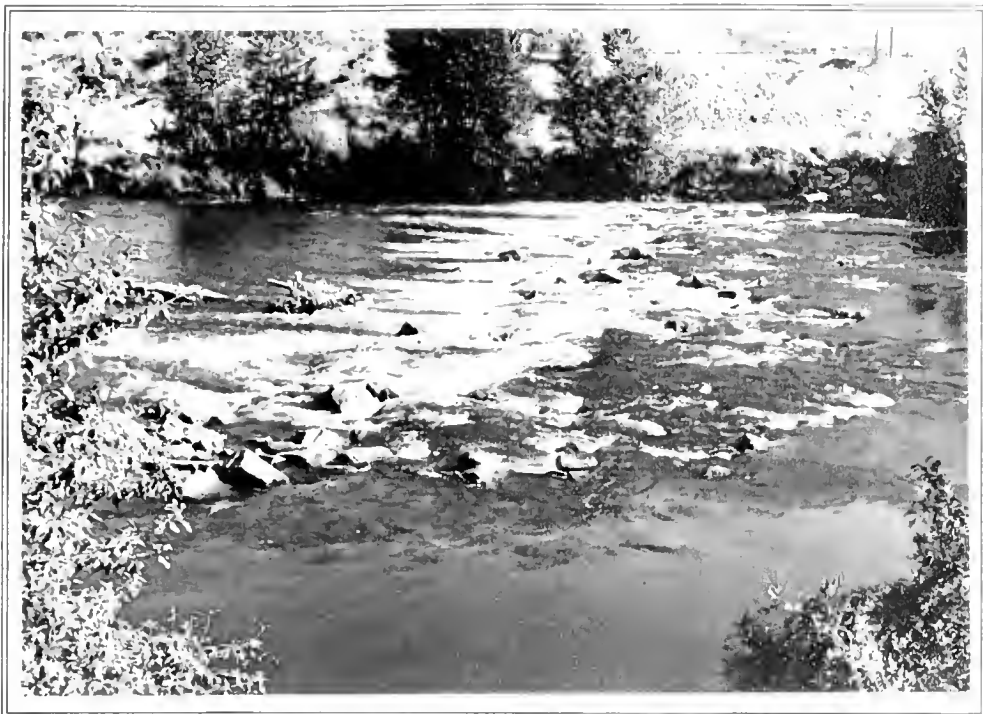
As noted in Section 2.2, the existing rock diversion structure is in good condition. There is some erosion on the bank of the approach channel near the intake structure and the rubble overflow weir or "blow-out" near the bypass structure exhibits significant leakage.

Missoula Irrigation District - Irrigation Diversion Structure

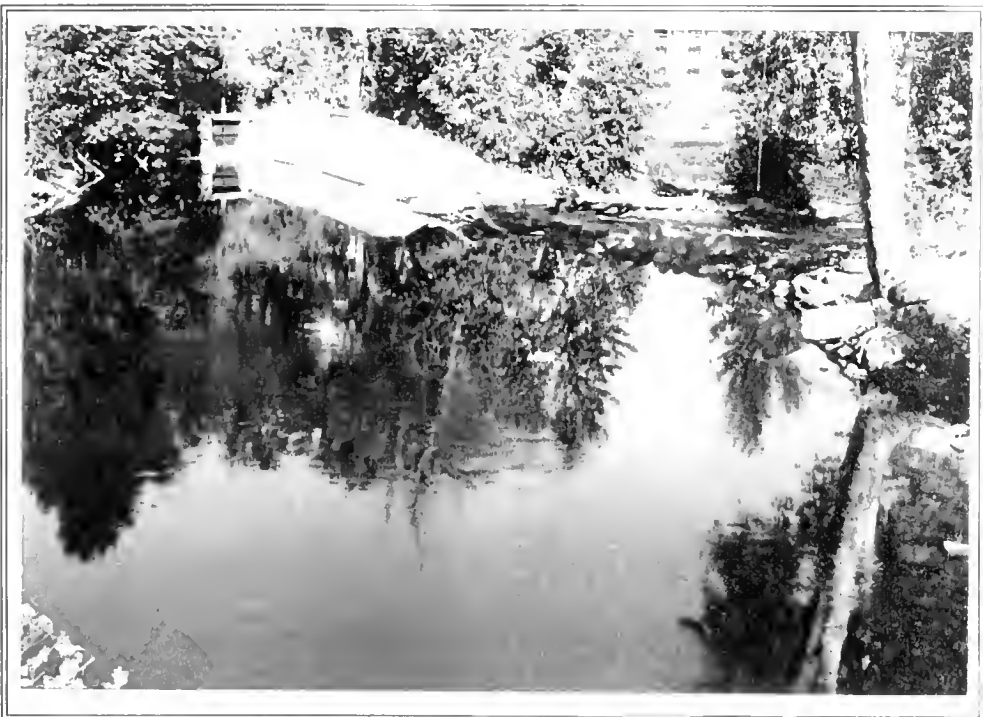
While no claims or law suits have been filed, there are a number of possible liability concerns which need to be addressed. Of particular concern is the open sluiceway below the stop boards of the bypass structure. At high water levels, the speed and volume of water here is a potential hazard since there is no grate, railing or enclosure to prevent anyone from slipping off the walkway and being quickly swept into the main river channel.

Missoula Irrigation District - Intake and Bypass Structures

Bank erosion near the intake structure should be repaired with riprap or gabion erosion protection.

Due to the heavy recreational use, there are a number of improvements which should be considered at this site. While some are aesthetic, many are critical to the safety of the public using this area. At a minimum, it is recommended that grates be placed over the two large openings in the by-pass structure. Also, an attractive hand rail system should be installed along the leading edge of the structure, especially over and around the stop boards.

The higher earthfill embankment is the recommended alternative based on aesthetics, recreational opportunities, safety and costs.

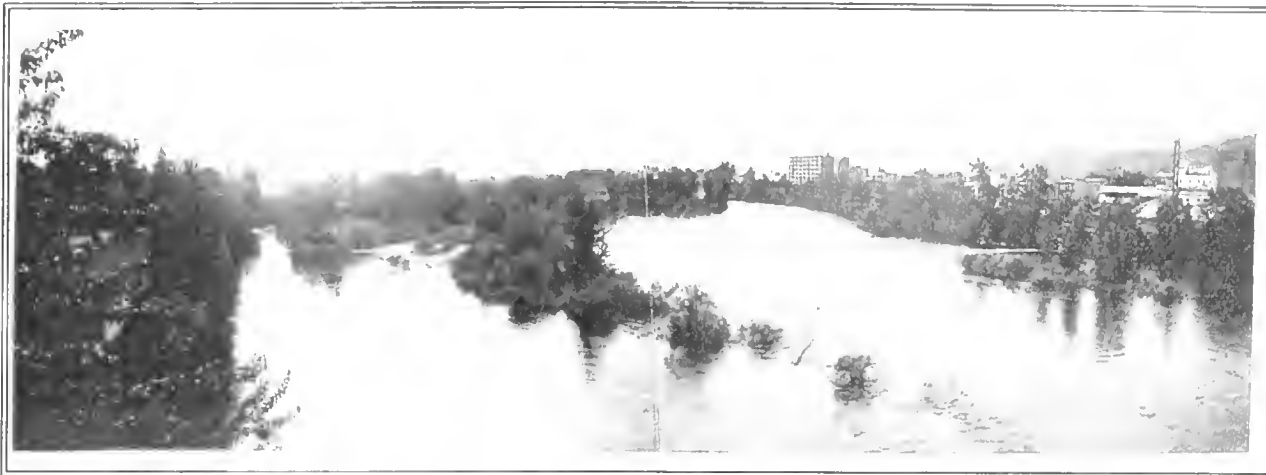
The Orchard Homes Irrigation Company's diversion system consists of a damaged timber floor irrigation diversion structure across part of the Clark Fork River, an existing rock groin and 750 ft. long approach channel along the left bank of the river, an intake structure with one vertical gate and a bypass structure to convey excess flows back to the river.

Orchard Homes Irrigation Company
Irrigation Diversion and Approach Channel

The rockfill structure is the recommended alternative based on costs

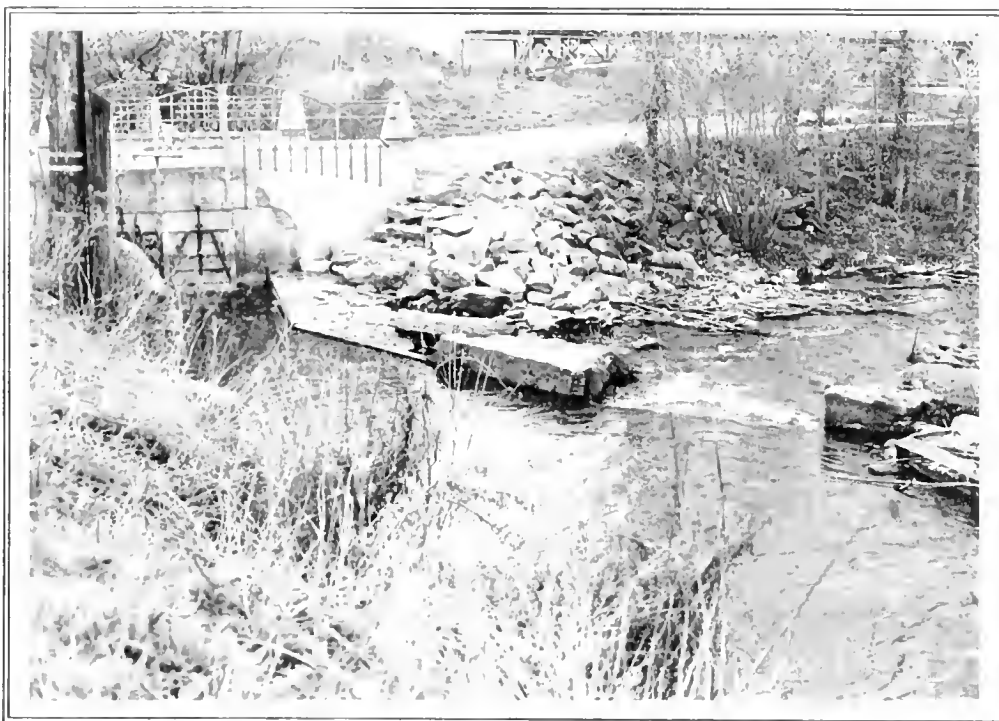
Orchard Homes Irrigation Company
Intake and Bypass Structures

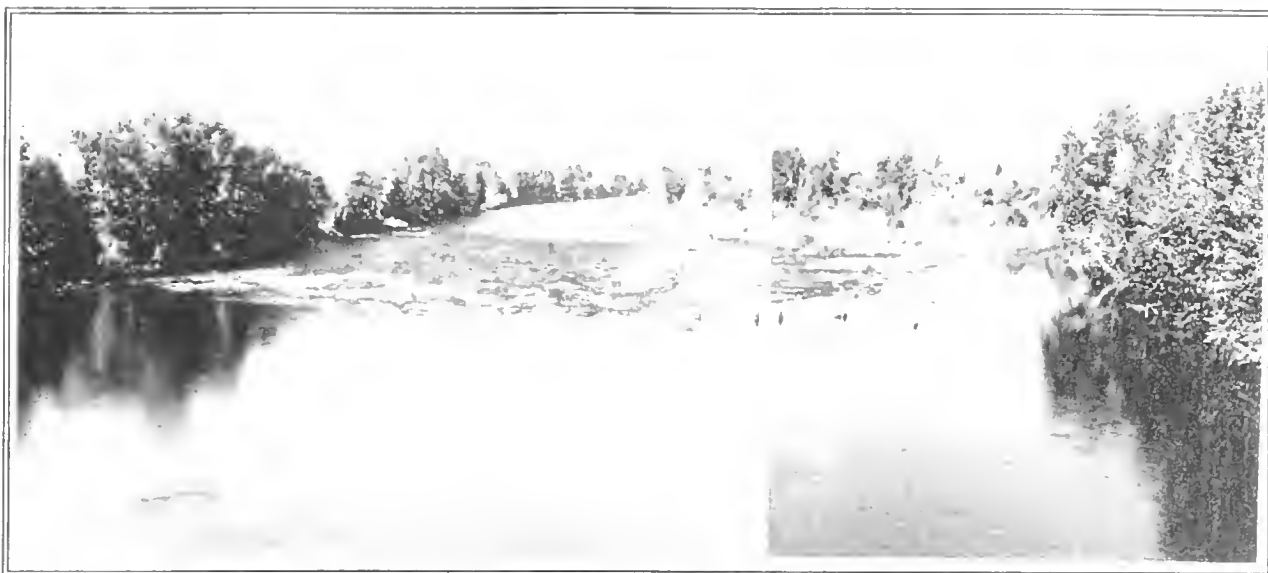
As noted in the site reconnaissance, the existing concrete intake and bypass structures are in good condition. There is a minor "blowout" along the approach channel and the diversion structure and rock groin have been repaired frequently to improve irrigation diversion during low river discharges.

Hellgate Irrigation Company
Irrigation Diversion Structure

An earthfill dike with a crest elevation of about elevation 3,167 ft. should be constructed across the "blowout". The groin running parallel to the flow should be built to the same elevation. The groin, dike and much of the surrounding ground on the island would be subject to overtopping by a flood of greater than 21,000 cfs. A flood of this magnitude is likely to occur at a frequency of about 1 in 5 years. The damaged sections of the groin or dike would then require repair. To prevent frequent overtopping a dike along most of the length of the approach channel would be required. The district should assess the overall merits of increasing the height of the dike.

The existing rock diversion structure across the river should be repaired or replaced along with the groins and dikes discussed above. The replacement diversion structures would be located just upstream of the existing rock diversion structure. Repair of existing rock diversion and three alternative diversion structures are discussed below:

Adding to the rockfill structure is the recommended alternative based on costs.

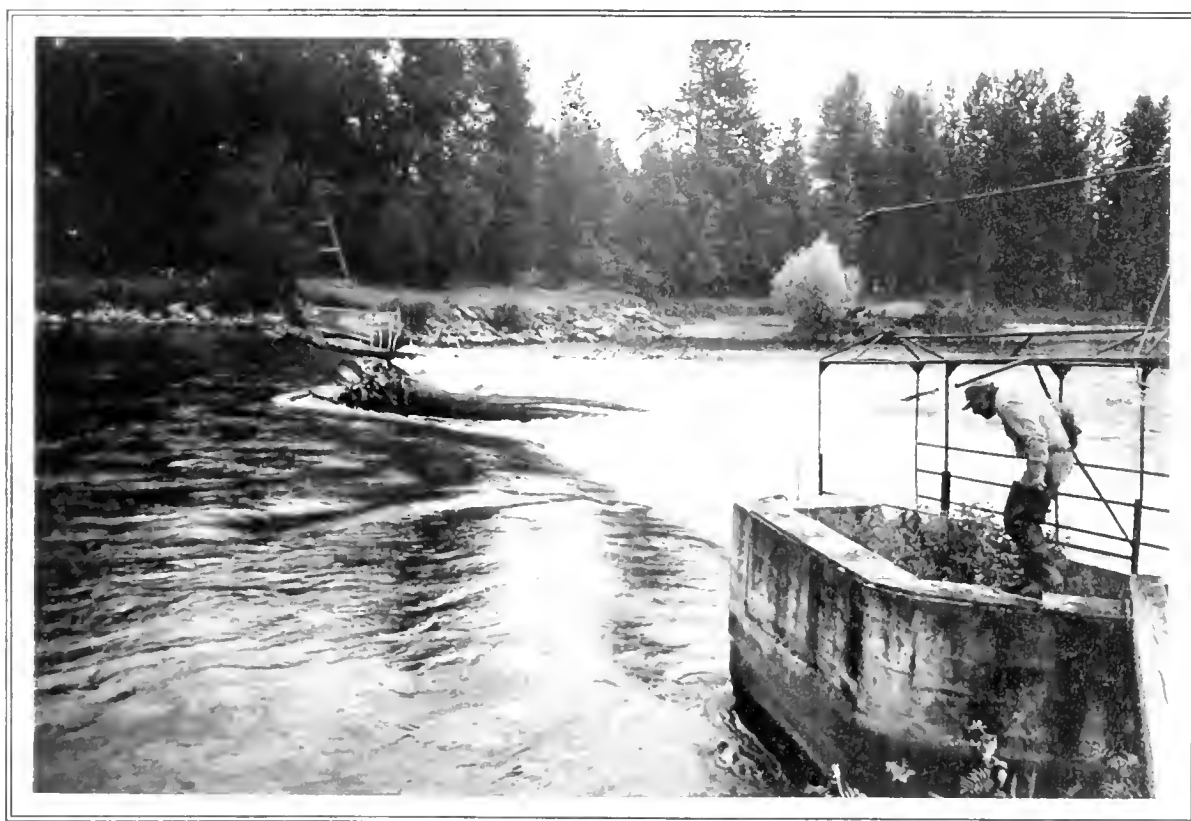
This diversion site operates satisfactorily with some difficulty during low river flows. It has experienced some erosion downstream of the structure but this has generally been repaired. The installation of the timber stoplogs is difficult and is accomplished from a trolley suspended from a cable.

Grass Valley - French Ditch Irrigation Company
Irrigation Diversion Structure

Short term plans for the diversion facilities should include maintenance of the erosion protection of the river bed downstream and upstream of the timber floor. Diligent maintenance with large rock (minimum 3 ft. diameter) will prevent any future undercutting and damage to the timber floor. To improve the timber check installation procedure, the cable supporting the trolley should be tightened and a lightweight, non-slip grating should be installed as the trolley floor.

The timber floor is the recommended alternative based on costs and past performance.

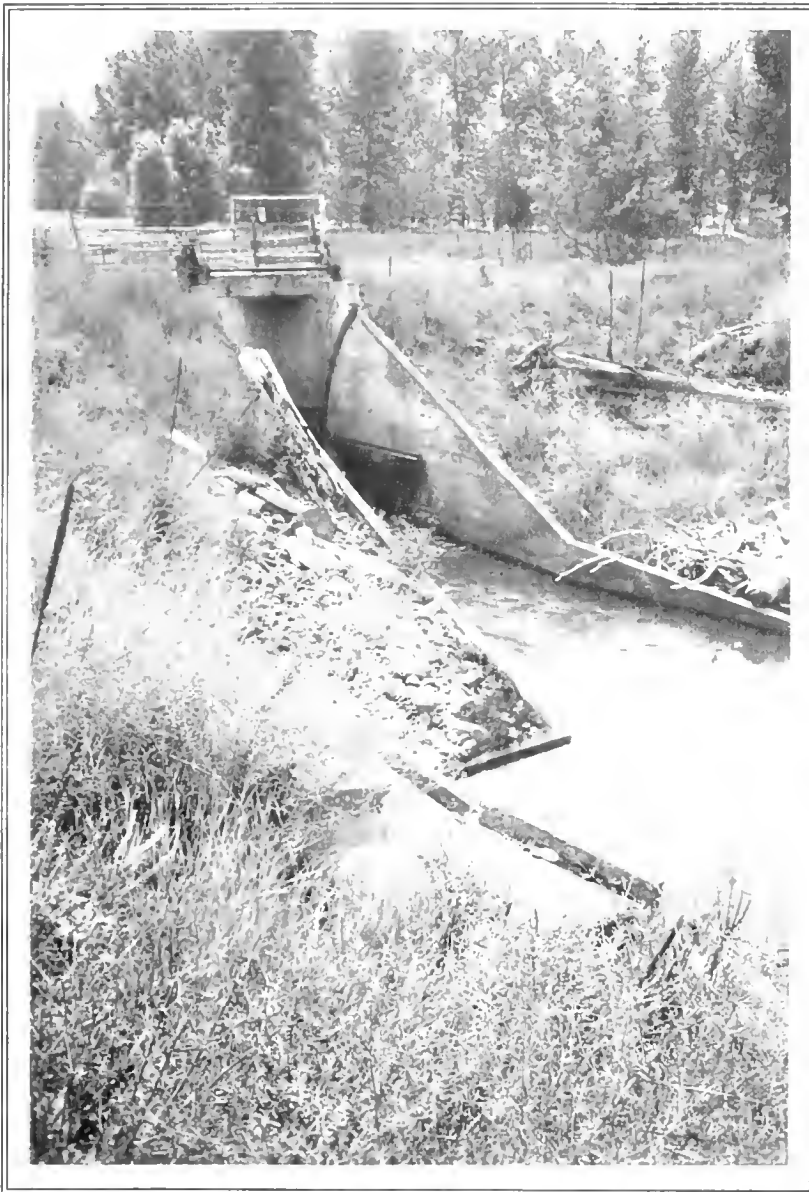
The existing diversion system generally operates satisfactorily with only occasional diversion problems during low river flow. There is a minor "blowout" along the approach channel and some leakage under the radial gate at the bypass structure.

Frenchtown Irrigation District
Bypass Structure
